Orange County Sanitation Dist. Plant 2

Tree Assessment-Construction Impact Report

October 5, 2022

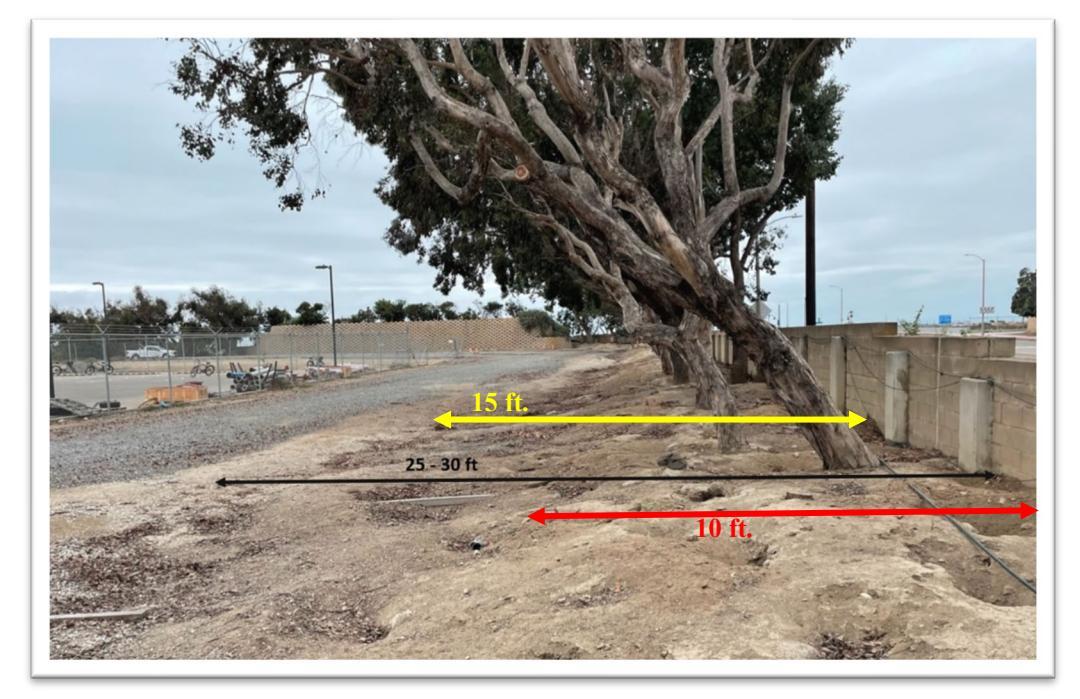
Below: The black arrow shows the extension of the trees' canopies towards the planned construction area. Additional space is required for excavation and equipment to perform the CDSM, which will move impacts to within 10 feet of the wall (red arrow). The yellow arrow indicates the location of the new building wall, 15 feet from the wall.

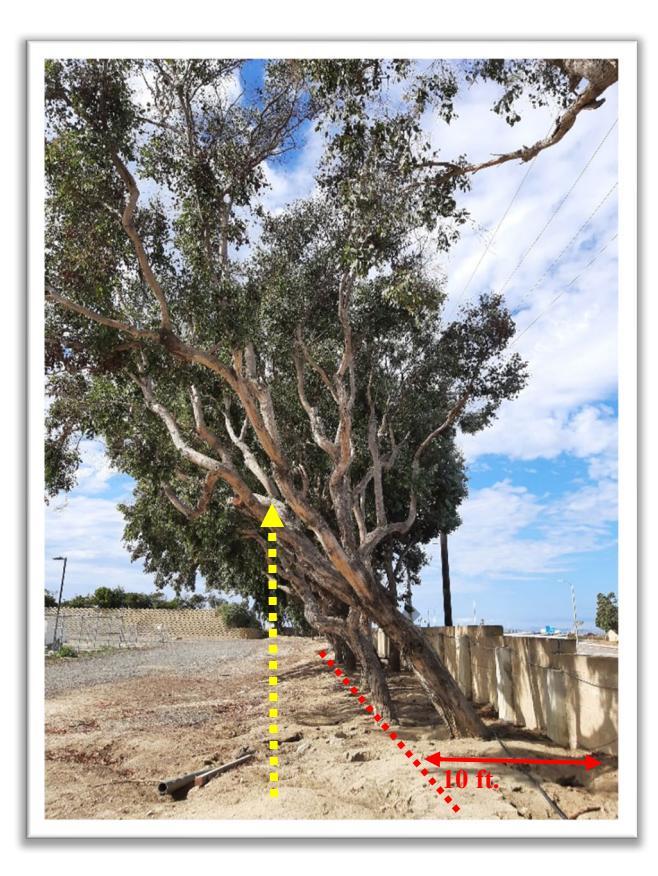
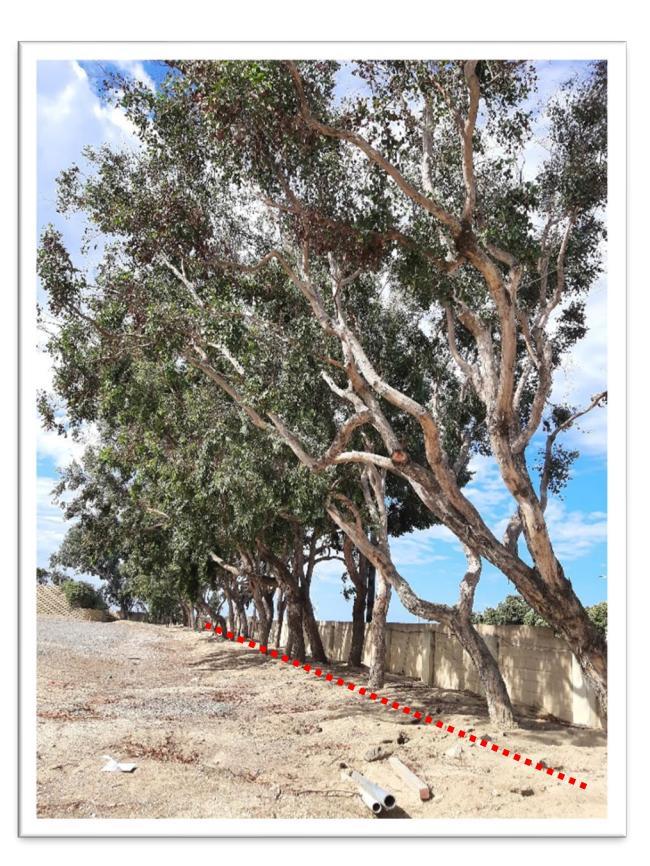
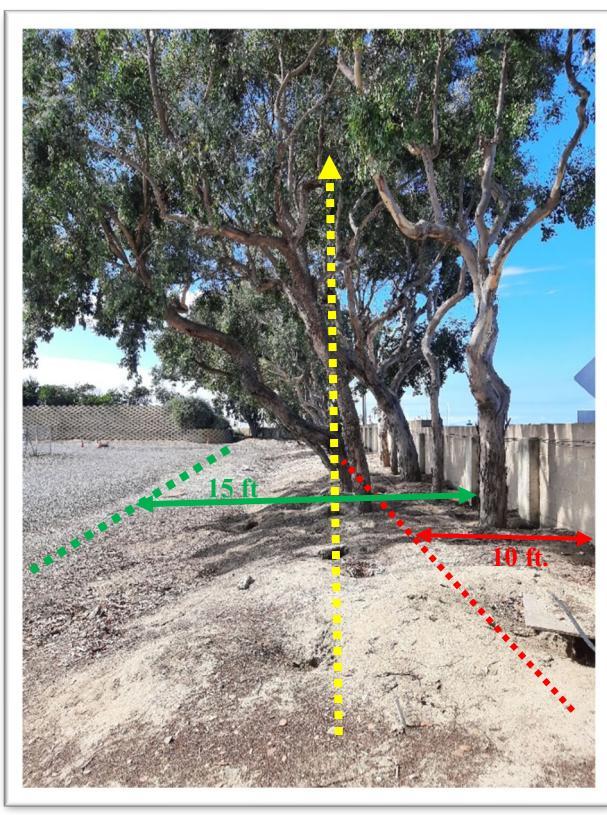
Images 1-3. Showing the row of trees that will be adversely impacted by planned construction. The project will require encroachment within 10 feet of the block wall, severely damaging the roots and canopies of 45 trees. In addition to the horizontal clearance needed, a high degree of canopy reduction would be necessary to accommodate equipment, vehicle, and completed building heights. Based on the overall health and condition of the trees, they are not considered good candidates for retention.

Image 3 also shows where the building will be (green), which is 15 feet from the block wall. This is not a sufficient distance to be able to safely protect the roots or canopies of the trees.

It is my recommendation that the trees be removed prior to construction starting, being sure to follow all applicable regulations with regards to verifying that no active bird nests or other protected wildlife are present within the tree canopies. New trees should be selected based on their size at maturity as well as their cultural needs. The planting site may require amendments to the soil including installing mulch and returning irrigation to the site, ensuring the best possible chance of a healthy establishment.

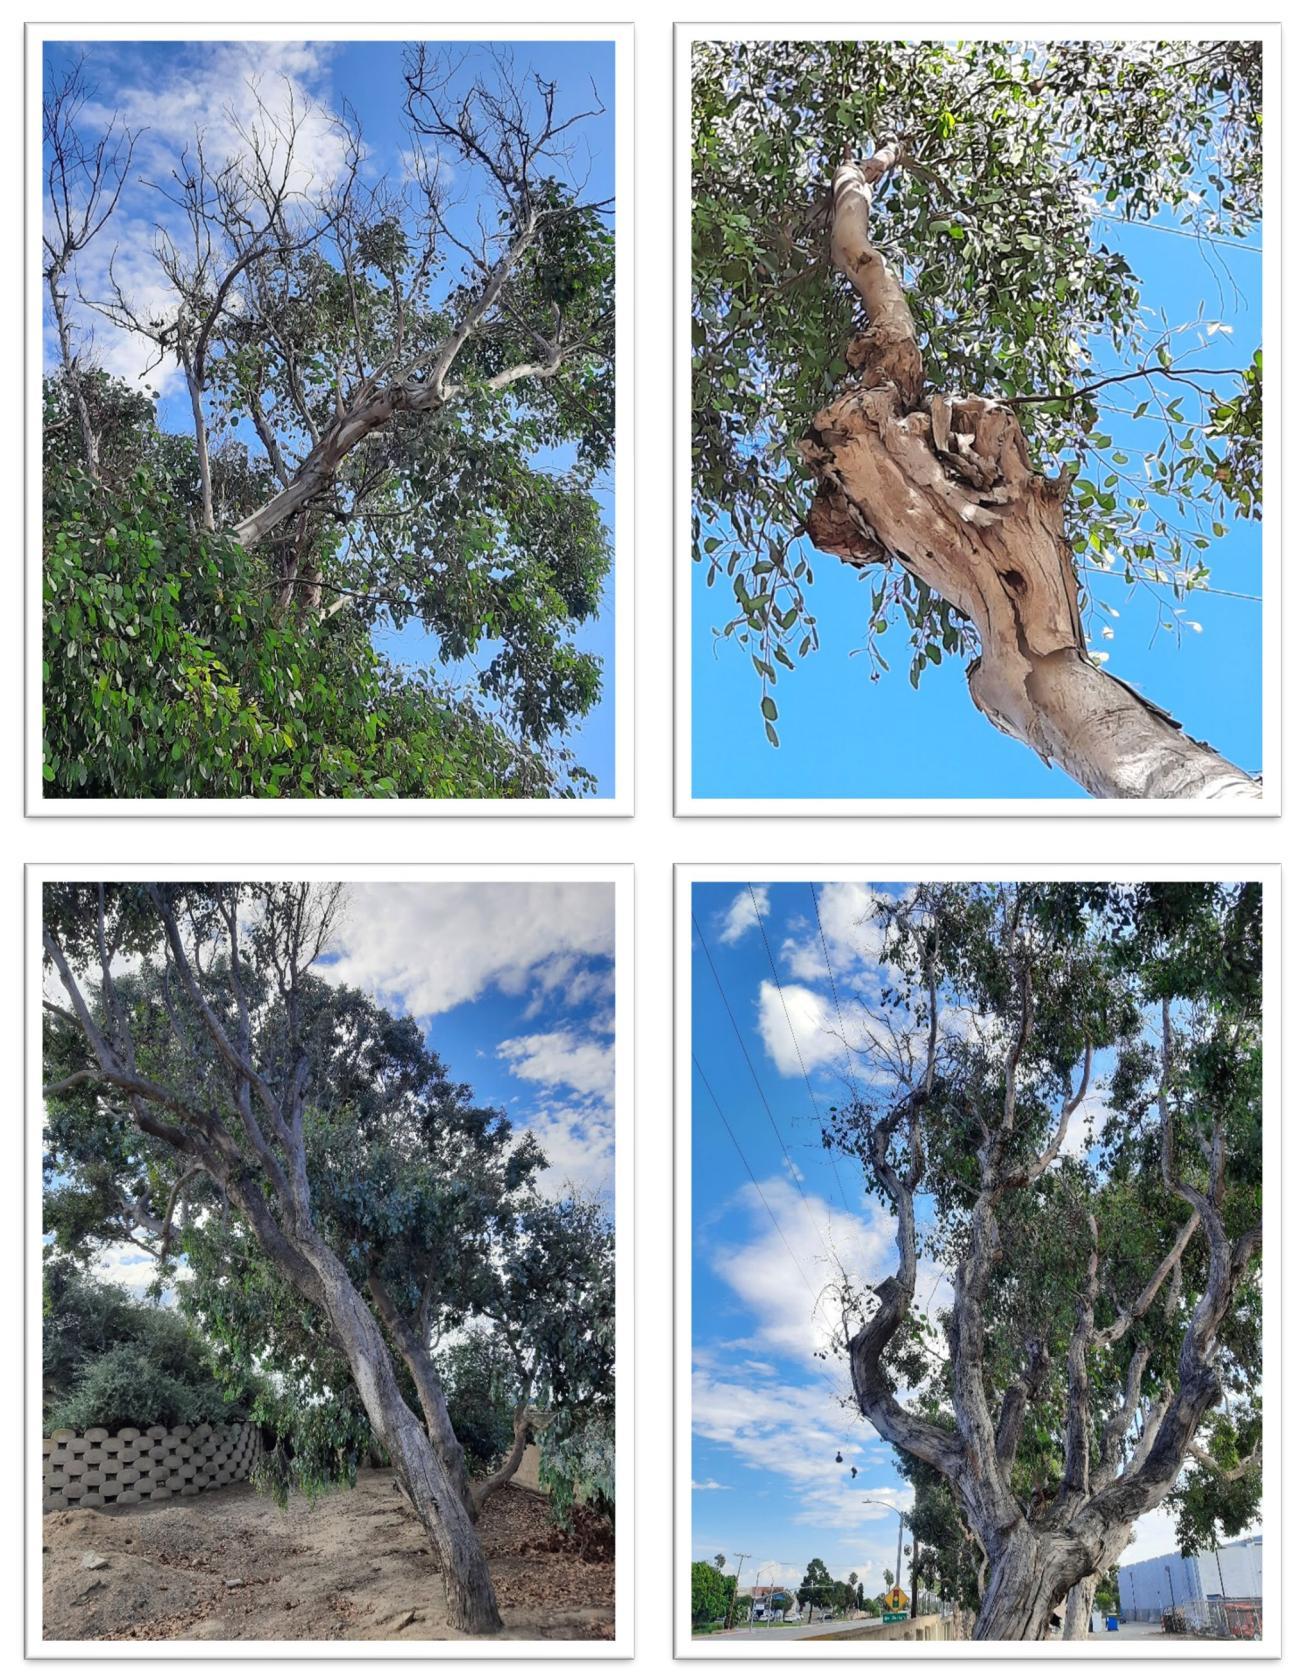
Images 4-7. Showing examples of the poor health, structure, and form of the subject trees.

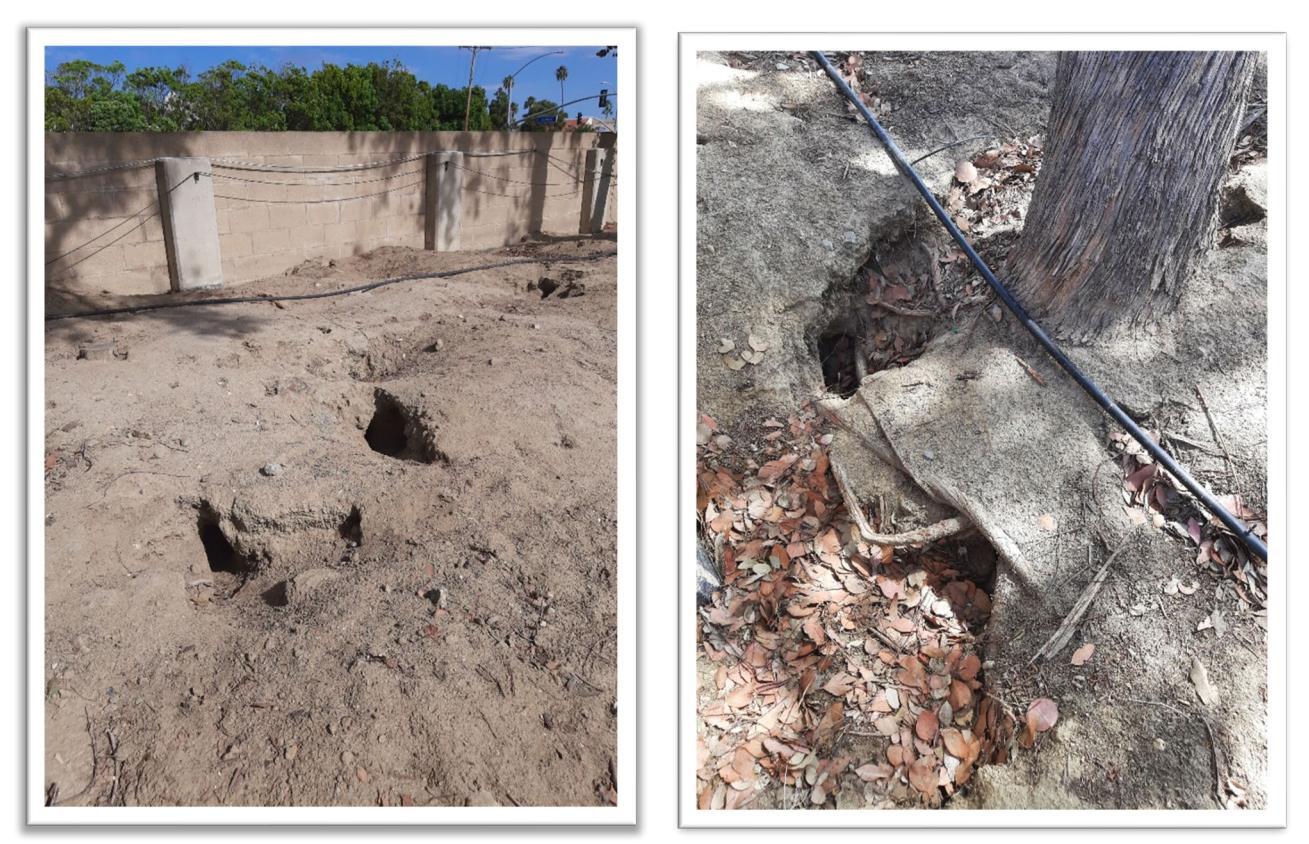
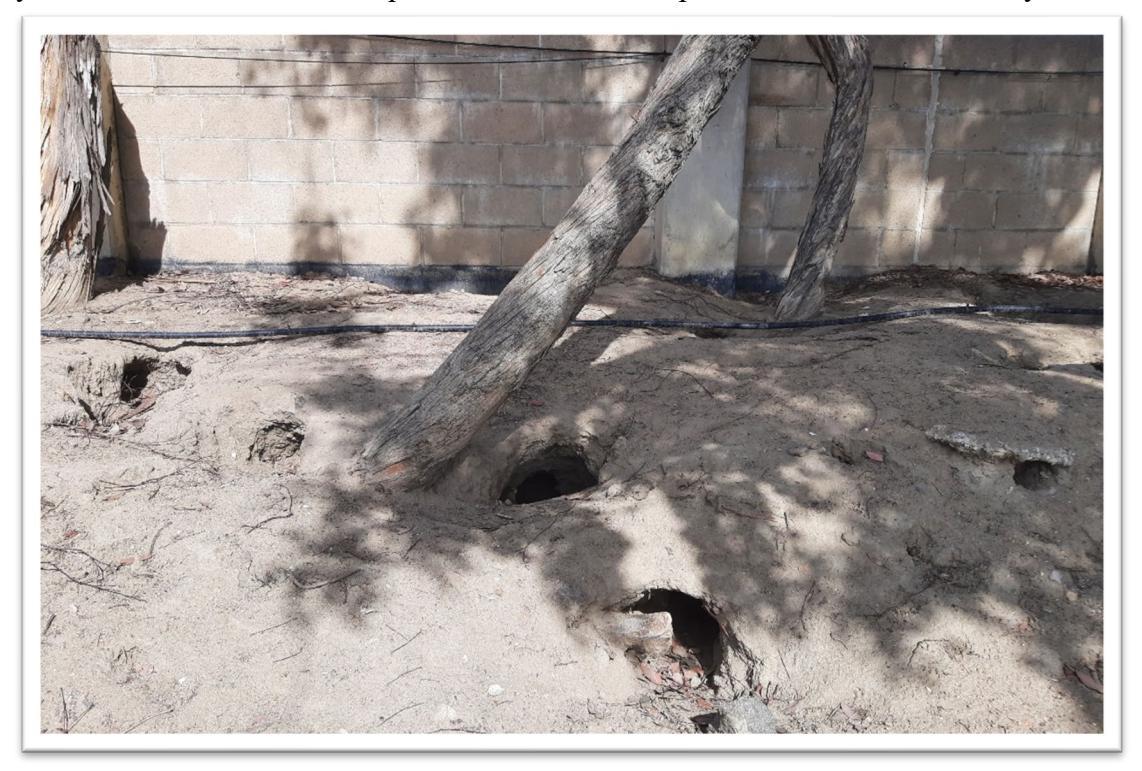
Images 8-10. Showing examples of where many of the trees have been undermined by the burrowing actions of ground squirrels. The soil around the trees is very dry and soft, giving way easily underfoot. Construction impacts would further impact tree health and stability.

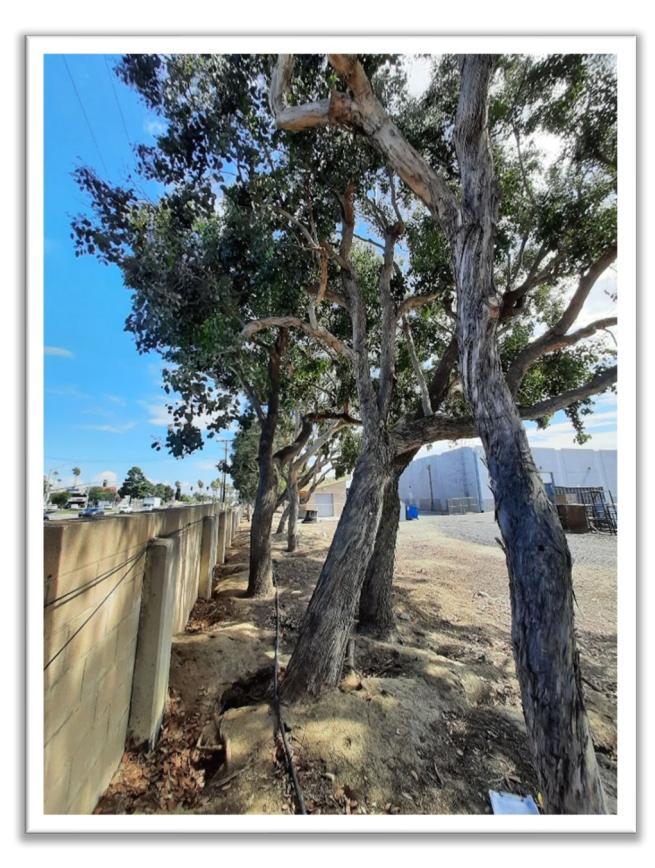
Image 11 (top-left). The soil around the trees is very dry and soft and full of animal burrows, which has compromised the stability of many of the trees.

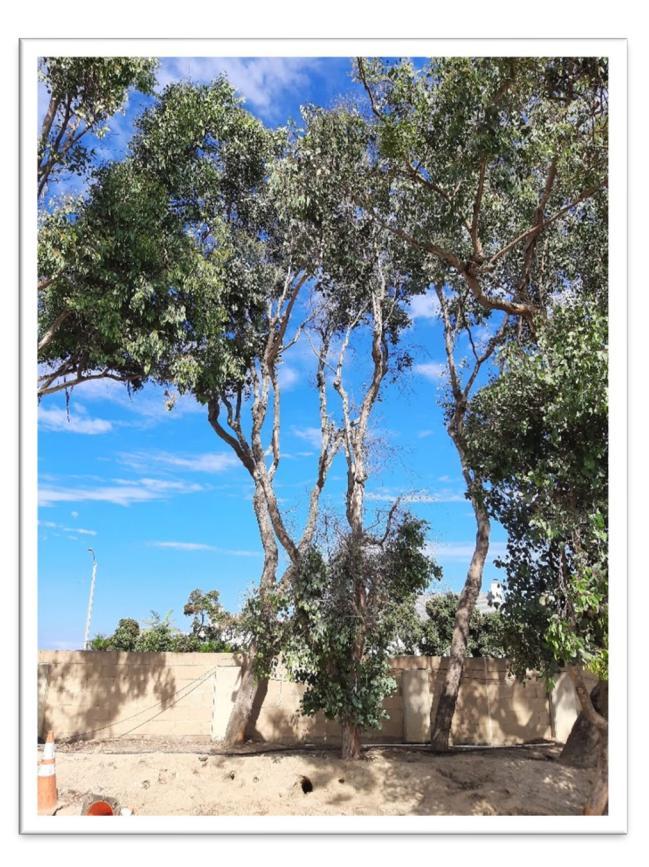
Image 12 (top-right). Showing more of the trees with poor health and condition. These trees are not considered ideal candidates for site retention.

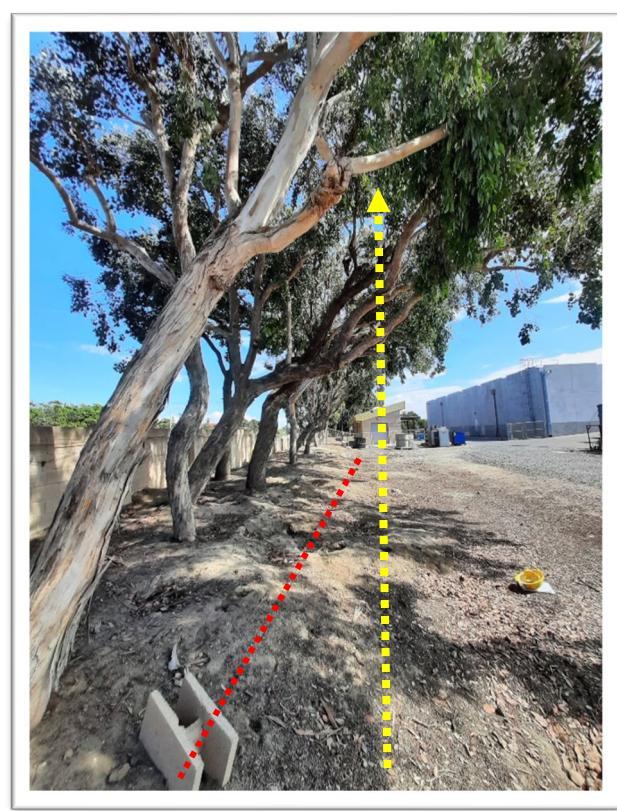
Image 13 (left). Shows another view of the way planned construction will encroach into the critical root zone and canopies of the subject trees.
