Orange County Sanitation Dist. Plant 2

Tree Assessment-Construction Impact Report

October 5, 2022

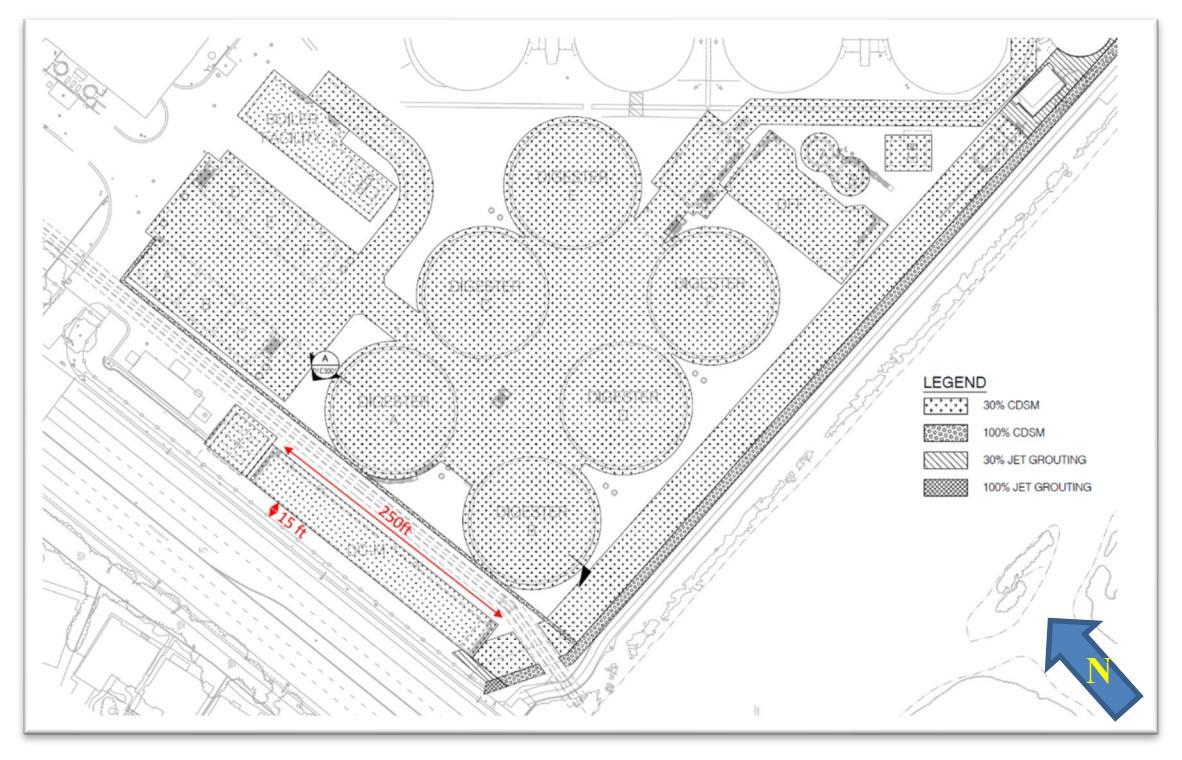
Map 2. Showing the site plan provided by the client: CDSM will be used to install footings along the western property line, at a length of 250 feet directly east of the trees.

Below: The black arrow shows the extension of the trees' canopies towards the planned construction area. Additional space is required for excavation and equipment to perform the CDSM, which will move impacts to within 10 feet of the wall (red arrow). The yellow arrow indicates the location of the new building wall, 15 feet from the wall.
